**WINGS - SPAR 1 OF THE WING AND WING TIP - INSPECTION**

<b>PART I</b>	<b>LH SPAR 1 OF THE WING AND WING TIP - INSPECTION</b>
Applicable to:	<a href="#">1.A. SB EFFECTIVITY</a>

<b>PART II</b>	<b>RH SPAR 1 OF THE WING AND WING TIP - INSPECTION</b>
Applicable to:	<a href="#">1.A. SB EFFECTIVITY</a>

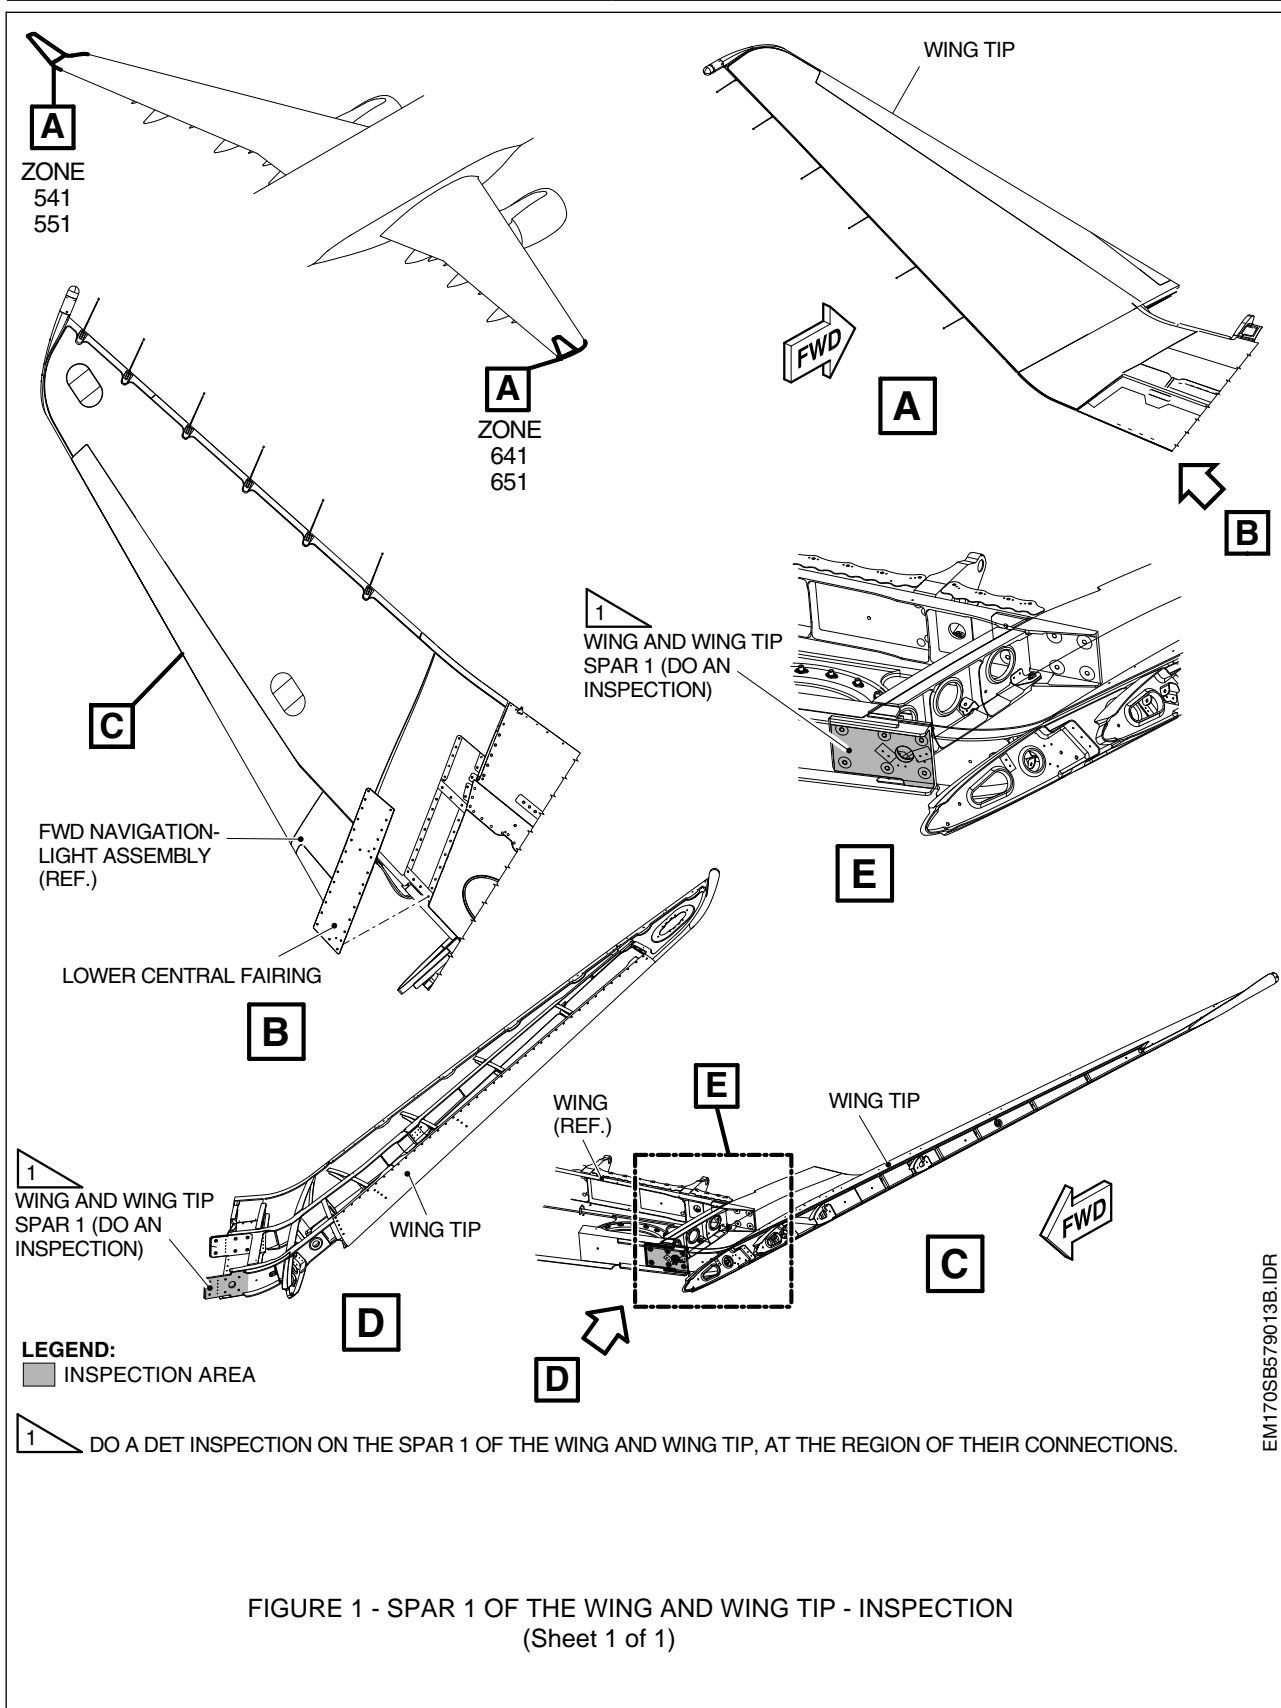
SB PART	FIGURE	FIGURE TITLE
I and II	<a href="#">Figure 1</a>	SPAR 1 OF THE WING AND WING TIP - INSPECTION

Further Engineering analysis concluded that this event occurred due to premature crack propagation on the forward spar (spar 1) of the enhanced wing tip. The preventive modification for this issue is addressed in [SB170-57-0072](#) (WINGS - WING TIP - SPAR 1 REPLACEMENT).

- FLAP ACE 2 - RHCBP (DC ESS BUS 3 FLIGHT CONTROLS)
  - FLAP ACE2 AC PWR - RICC (AC BUS 2)
  - HYDR ELEC PUMP SYS 2 - LHCBP (DC BUS 1)
  - ACMP2B CMD - SPDA1 (CBMENU/CB BY SYS/HYD)
  - HYDR ELEC PUMP SYS 3A - LHCBP (DC ESS BUS 1)
  - E1 START VLV - SPDA2 (CBMENU/CB BY SYS/ENGINE)
  - ACMP3B CMD - SPDA2 (CBMENU/CB BY SYS/HYD).
- (c) Use a workstand to get access to the work area.
- (d) Remove access panel 551AB. Refer to AMM TASK 06-44-00-800-801-A/100 - Wing Access Doors and Panels.
- (e) Remove the wing tip fairing. Refer to AMM TASK 57-30-25-000-802-A/400 - Wing Tip Fairing Enhanced - Removal.
- (2) Do a Detailed Inspection (DET) on the spar 1 of the Left-Hand (LH) wing and wing tip, at the region of their connections, to see if there is any crack(s) on them. Refer to [Figure 1](#) for reference area to be inspected.

- (c) Use a workstand to get access to the work area.
  - (d) Remove access panel 651AB. Refer to AMM TASK 06-44-00-800-801-A/100 - Wing Access Doors and Panels.
  - (e) Remove the wing tip fairing. Refer to AMM TASK 57-30-25-000-802-A/400 - Wing Tip Fairing Enhanced - Removal.
- (2) Do a Detailed Inspection (DET) on the spar 1 of the Right-Hand (RH) wing and wing tip, at the region of their connections, to see if there is any crack(s) on them. Refer to [Figure 1](#) for reference area to be inspected.

- (a) If any crack is found on the spar 1 of the wing tip, accomplish [SB170-57-0072](#) immediately.
- (b) If any crack is found on the spar 1 of the wing, accomplish [SB170-57-0073](#) immediately.

- (a) If any crack is found on the spar 1 of the wing tip, accomplish [SB170-57-0072](#) immediately.
  - (b) If any crack is found on the spar 1 of the wing, accomplish [SB170-57-0073](#) immediately.
